N3 Virginia Bypass
Stage F Part 2 Road Safety Audit

Barry Transportation

November 2021

Stage F Part 2 Road Safety Audit

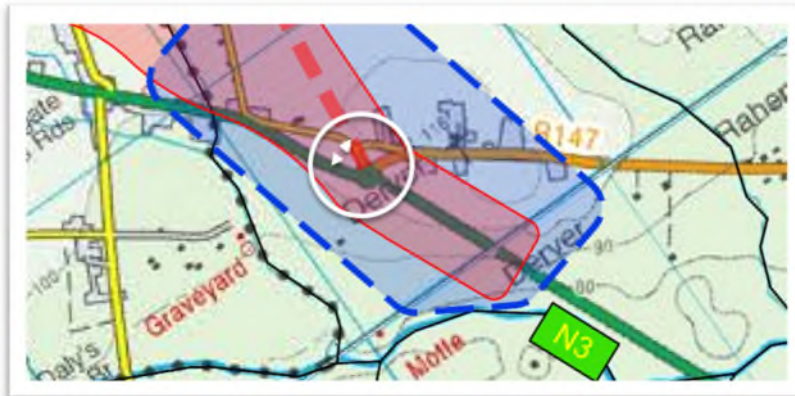
Figure 2.1 – Separation Between Roundabout Arms

Location: Roundabout at Chainage 0+000m

The new junction arm will be in close proximity to the arm serving the existing N3 route. This could lead to driver confusion, late braking, and side swipe type collisions.

Greater separation should be provided between the junction arms described.

2.1	Y	Y	Appropriate separation will be investigated in further detail during Phase 3 of planning and design process.	Noted
2.2	Y	Y	Appropriate drainage measure will be investigated in further detail during Phase 3 of planning and design process.	Noted

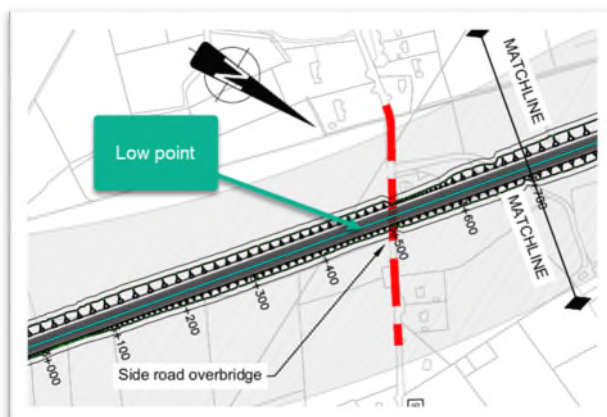
Figure 2.2 – Low Point in Vertical Profile

Location: Mainline Chainage 3+460m

The low point at Chainage 3.460m coincides with a number of house dwellings. This could lead to surface water run-off gathering around the houses during significant rainfall events.

Appropriate drainage measures should be provided to mitigate the risk described.

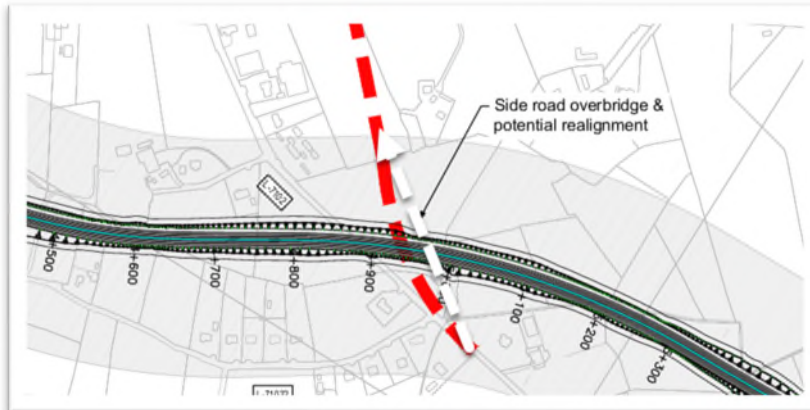
Figure 2.3 – SSD at Side Road / Underbridge

Location: Side Road L-7103 Re-Alignment Mainline Chainage 4+950m

The overbridge could limit forward stopping sight distance on the side road, leading to rear end shunts or loss of control type collisions.

Appropriate forward stopping sight distance should be provided at the location described.

2.3	Y	Y	Appropriate visibility requirements will be investigated in further detail during Phase 3 of planning and design process.	Noted
2.4	Y	Y	Appropriate visibility requirements will be investigated in further detail during Phase 3 of planning and design process.	Noted

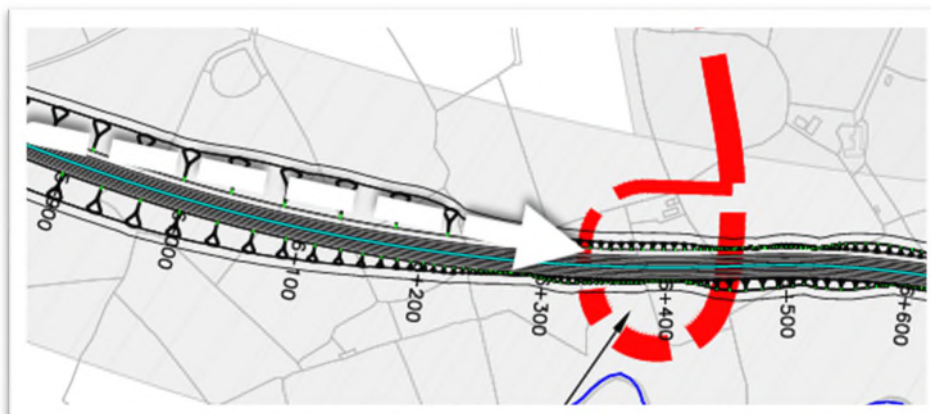
Figure 2.4 – Embankment on Approach to Junction

Location: Alignment Mainline Chainage 4+950m

The cutting earthworks could obscure the presence of the junction for northbound drivers. This could lead to late braking and rear end shunt type collisions.

The earthworks should be designed to ensure that the junction is 'self-reading' on approach.

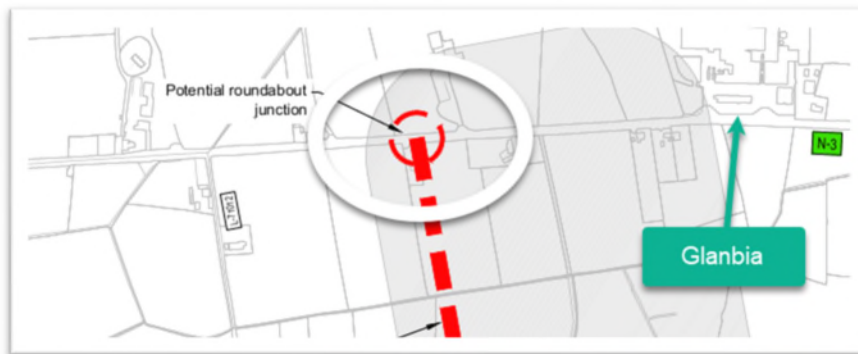
Figure 2.5 – Conspicuousness of Roundabout

Location: Connection to Existing N3 at Mainline Chainage 6+000m

The roundabout appears to be located near a vertical crest on the existing N3, which could lead to drivers failing to observe the junction's presence. Inappropriate forward visibility to the junction may result in motorists failing to appreciate the road layout increasing the risk of a collision here.

Appropriate forward visibility should be provided on the roundabout approaches.

2.5	Y	Y	Appropriate visibility requirements will be investigated in further detail during Phase 3 of planning and design process.	Noted
2.6	Y	Y	Appropriate visibility requirements will be investigated in further detail during Phase 3 of planning and design process.	Noted

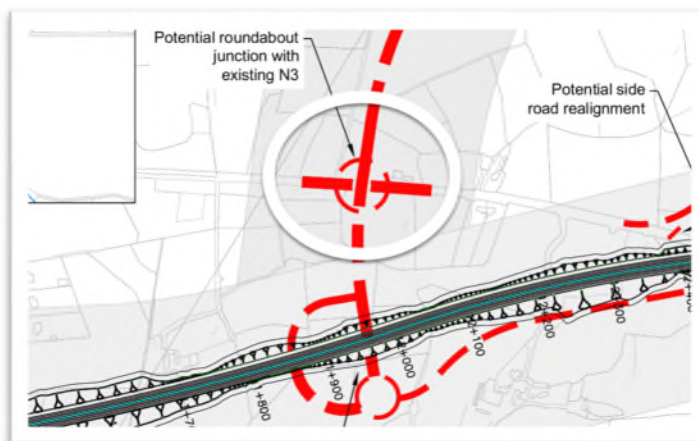
Figure 2.6 – Need for 'Self Reading Junction Layout' for New Roundabout

Location: Existing N3 at South of Mainline Chainage 11+950m

The combination of high operating speeds and undulating vertical alignment could increase the risk of collisions at the new roundabout.

The approach alignment of the existing N3 should be designed to maximise the conspicuousness of the roundabout.

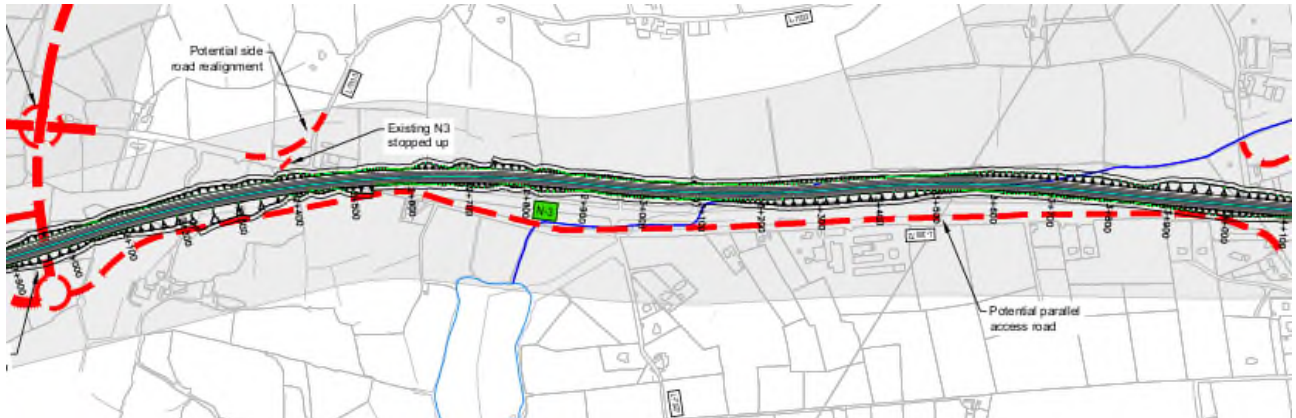
Figure 2.7 – Access Road Beside Mainline

Location: Mainline Chainage 12+100m to 12+900m

Where the access road will run parallel to the mainline, there is a risk of headlight distraction and an errant vehicle crossing from one road to the other.

Appropriate containment measures and screening should be provided at the location described.

2.7	Y	Y	Appropriate intervisibility screening and containment requirements will be investigated in further detail during Phase 3 of planning and design process.	Noted

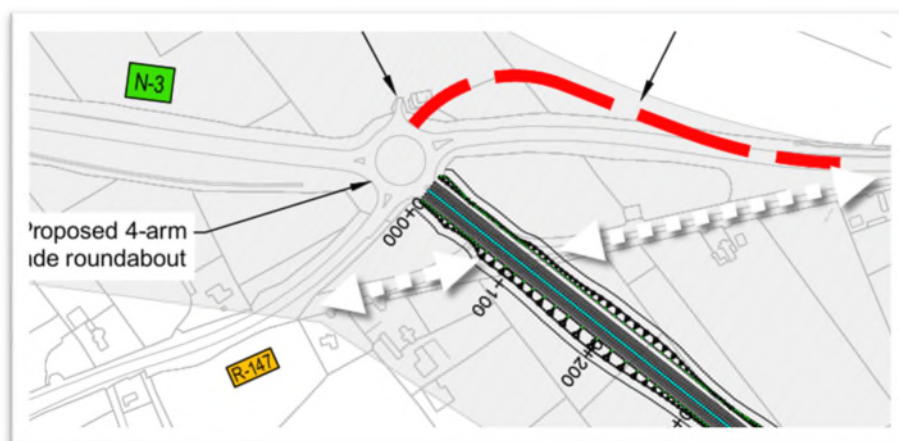
Figure 2.8 – Example Properties at Southern Tie In Where Access Provision will be Required

Location: Route Wide

Failing to provide suitable access to existing private properties which are directly impacted upon by the route, could lead to motorists undertaking prohibited (or unsafe) manoeuvres which might increase the risk of collisions occurring.

Appropriate access should be provided to existing properties which are directly impacted upon by the route.

2.8	Y	Y	Appropriate property and farmland access will be investigated in further detail during Phase 3 of planning and design process.	Noted
2.9	Y	Y	Appropriate property and farmland access will be investigated in further detail during Phase 3 of planning and design process.	Noted
